# New life for Fowler Beach

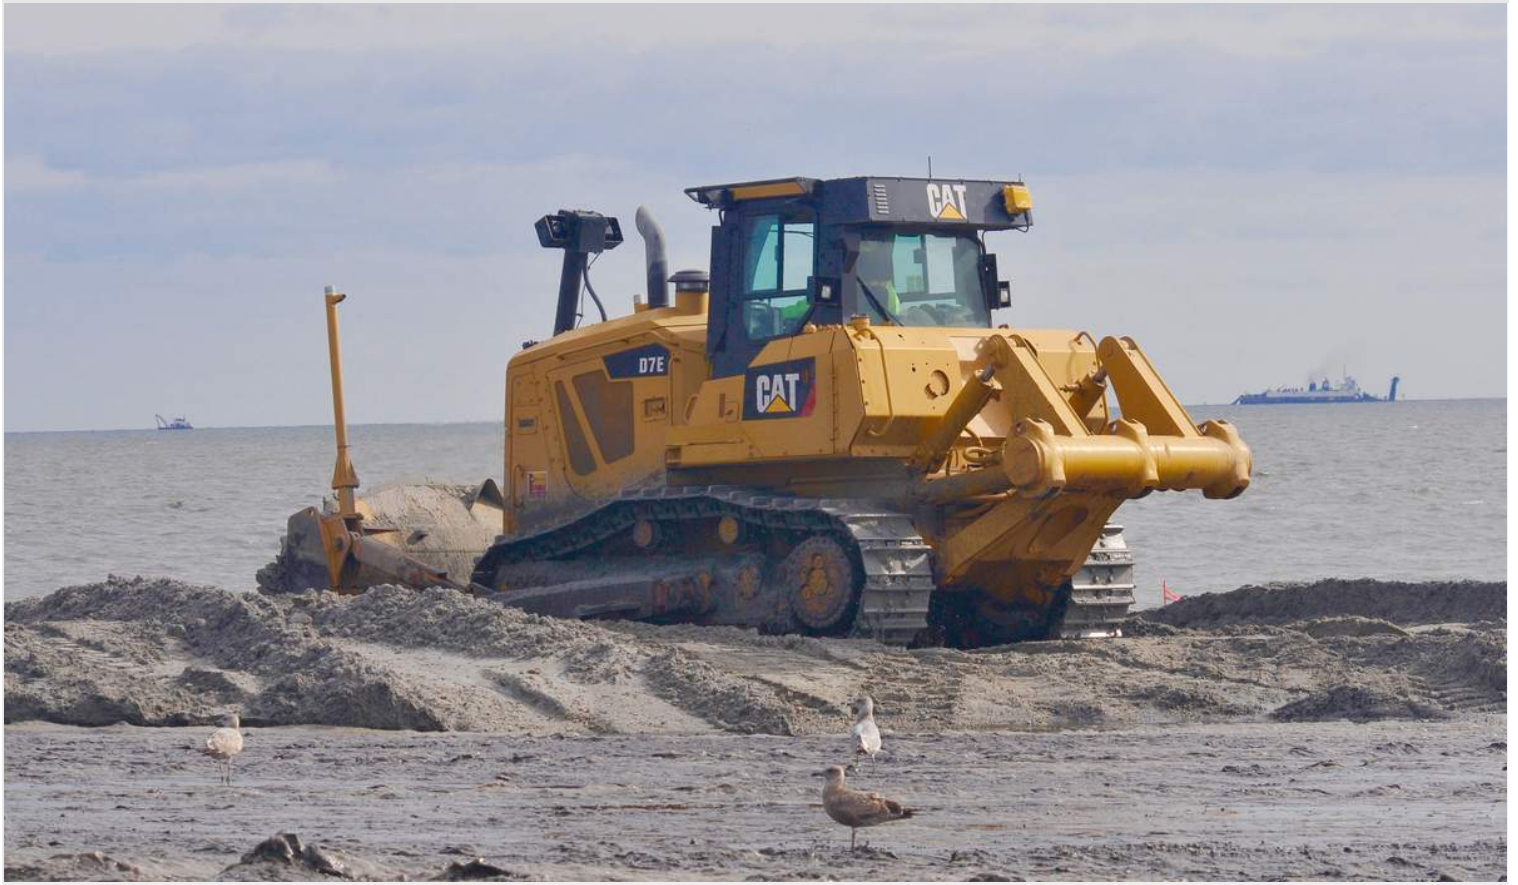
*Photo by: Ron MacArthur* With a dredge in the background more than a mile offshore, a bulldozer pushes sand to fill in a breach at Fowler Beach.

This week, the Norfolk Dredging Co. crew began to stockpile sand and push it into the widest and deepest breach along the refuge coastline.

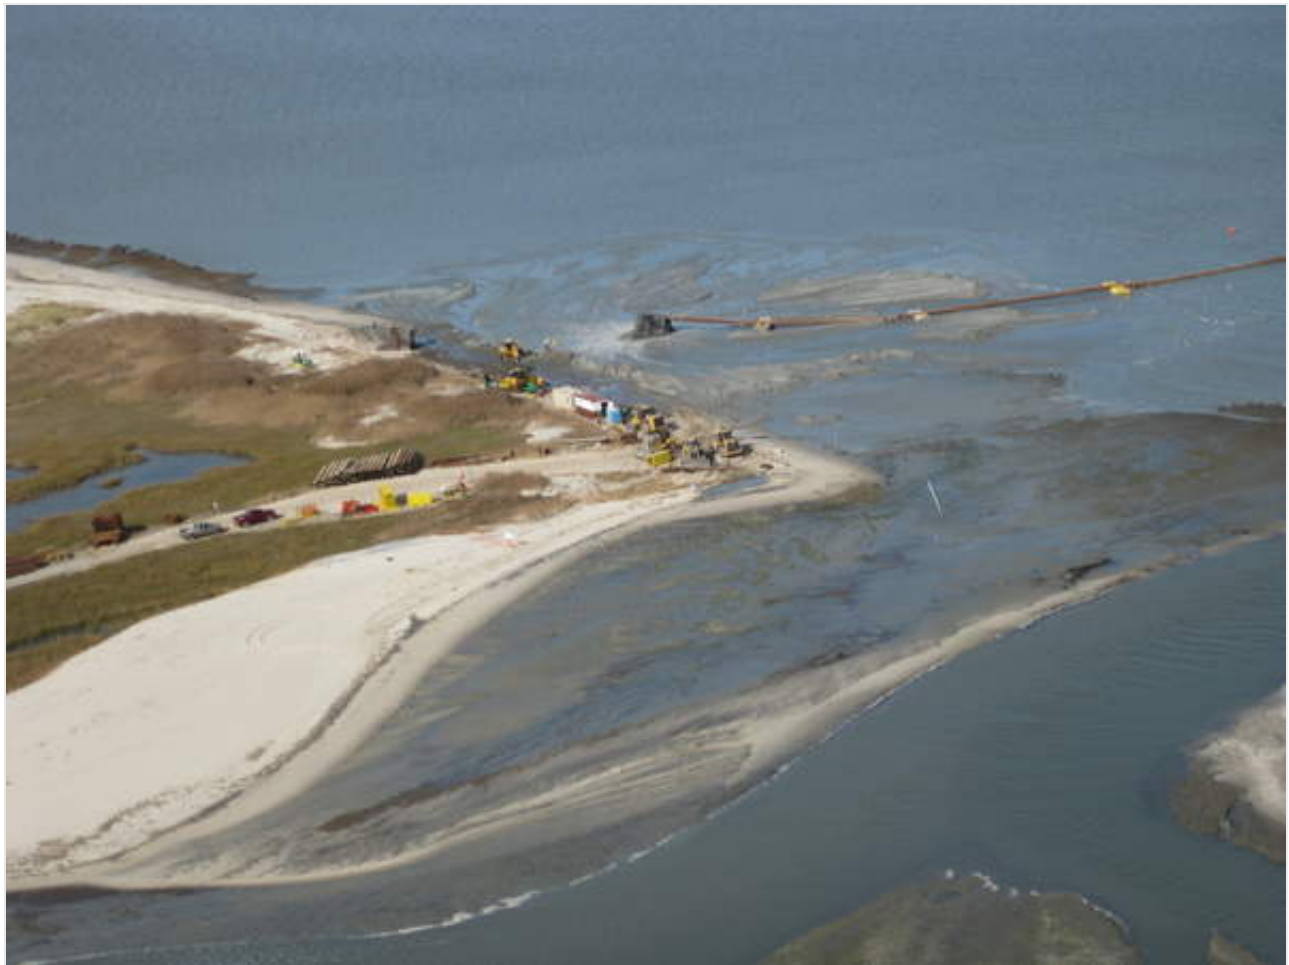
Since this photo was taken at the start of the dredging project, the crew has moved south to start filling in the large breach. *(Photo by: John Chirtea)*

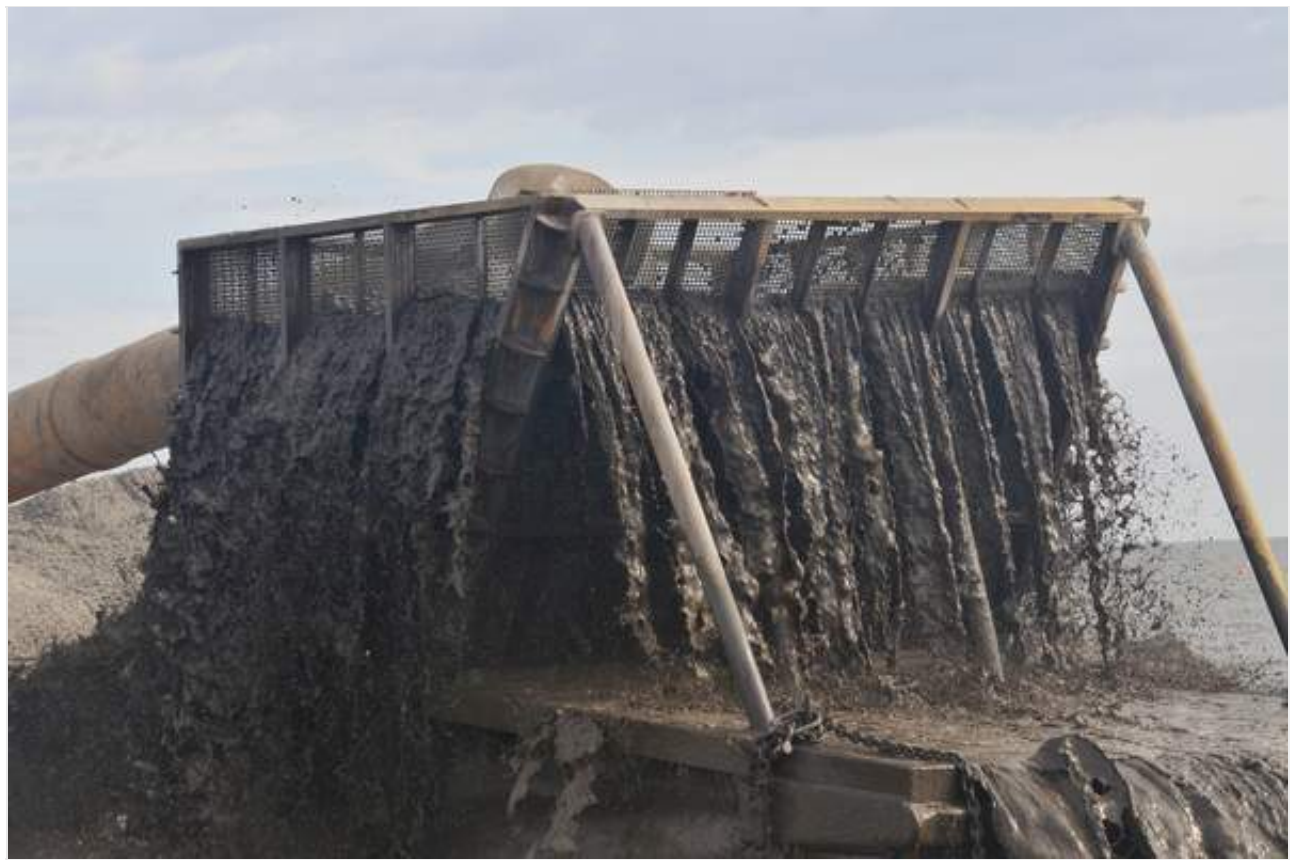
Sand is pumped from the floor of the Delaware Bay more than a mile to this screen to filter out any munitions buried in the sand. *(Photo by: Ron MacArthur)*

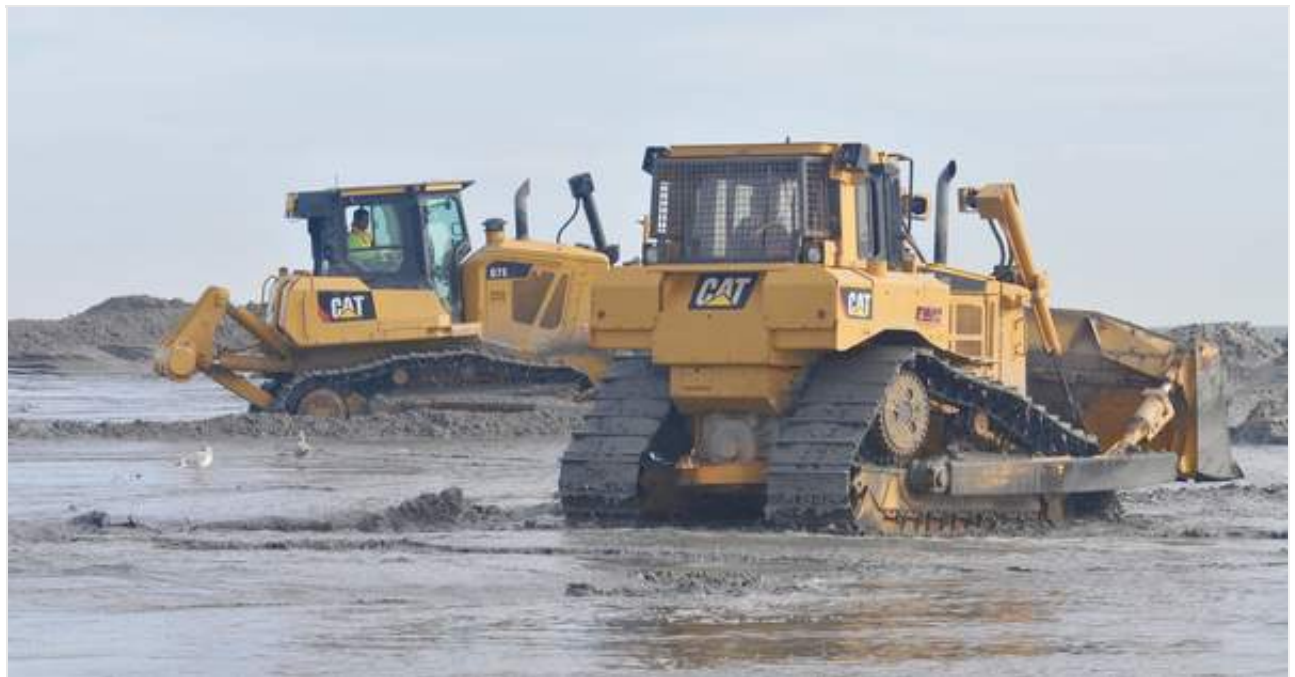
Over the next four to five months, bulldozers will move more than 1 million cubic yards of sand to rebuild the beachfront of Prime Hook National Wildlife Refuge. *(Photo by: Ron MacArthur)*

More than 1.1 million cubic yards of sand will be needed to rebuild the 1.5 miles of beach.

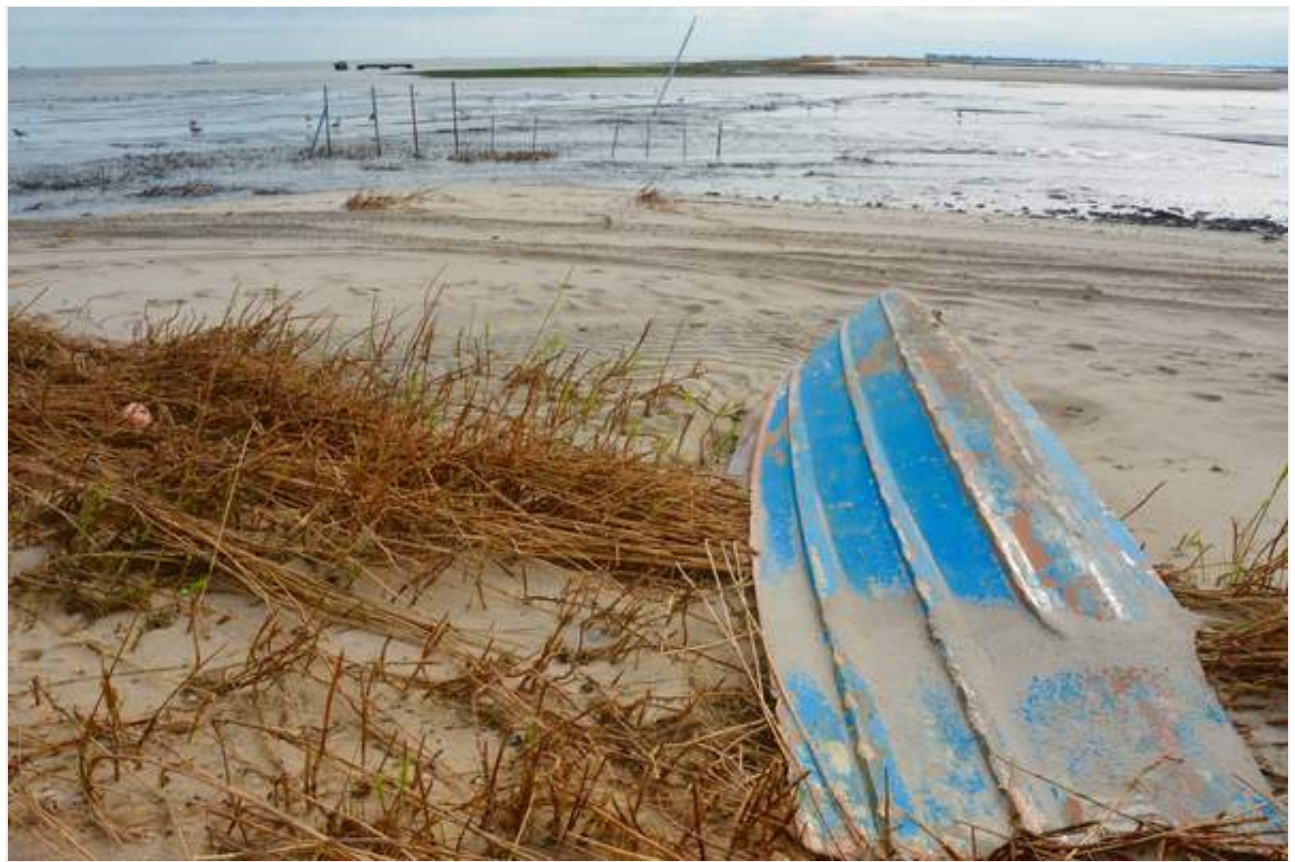
Opened by a series of storms over the past eight years, this is the largest breach along the shoreline. *(Photo by: Ron MacArthur)*

The Fowler Beach area – in the northern section of the refuge – suffered the most damage from a series of storms over the past eight years that pounded the coast, opening four breaches in the shoreline. The breaches allowed free flow of saltwater from

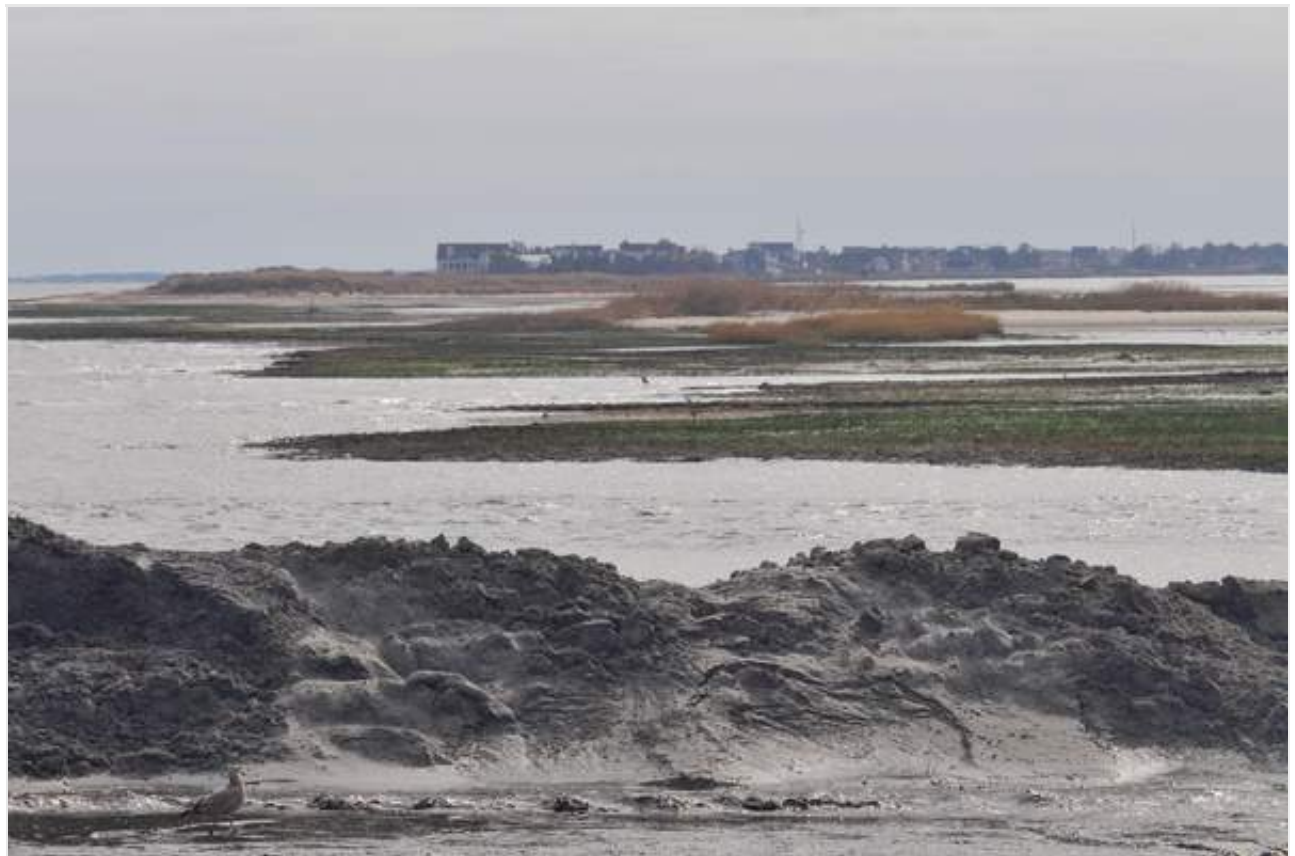
The goal of the project is to rebuild the beach and dune system to match the existing beach profile close to the village of Primehook Beach. In all, more than 6,400 feet of replenishment is planned using more than 1 million cubic yards of sand. *(Photo by: Ron MacArthur)*

The crew is working north to south to fill the breaches, replenish the beach and create a small dune to match the existing beach profile near the village of Primehook Beach.

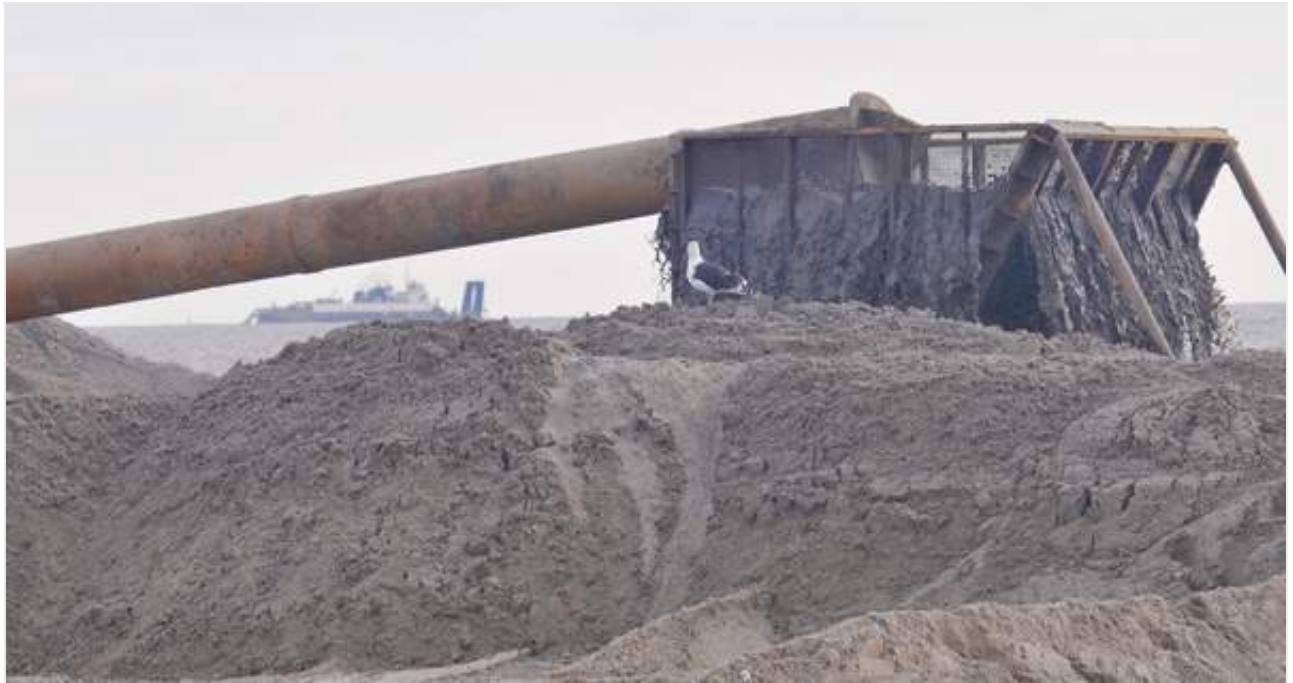
The dredge is working 24 hours a day pumping sand from more than one mile out in Delaware Bay. *(Photo by: Ron MacArthur)*

Since the beach dredging project started less than three weeks ago, about 600 feet of beach has been replenished by a 24-hour dredging crew pumping sand more than a mile off the coast. They are up against a mid-April 2016 deadline.

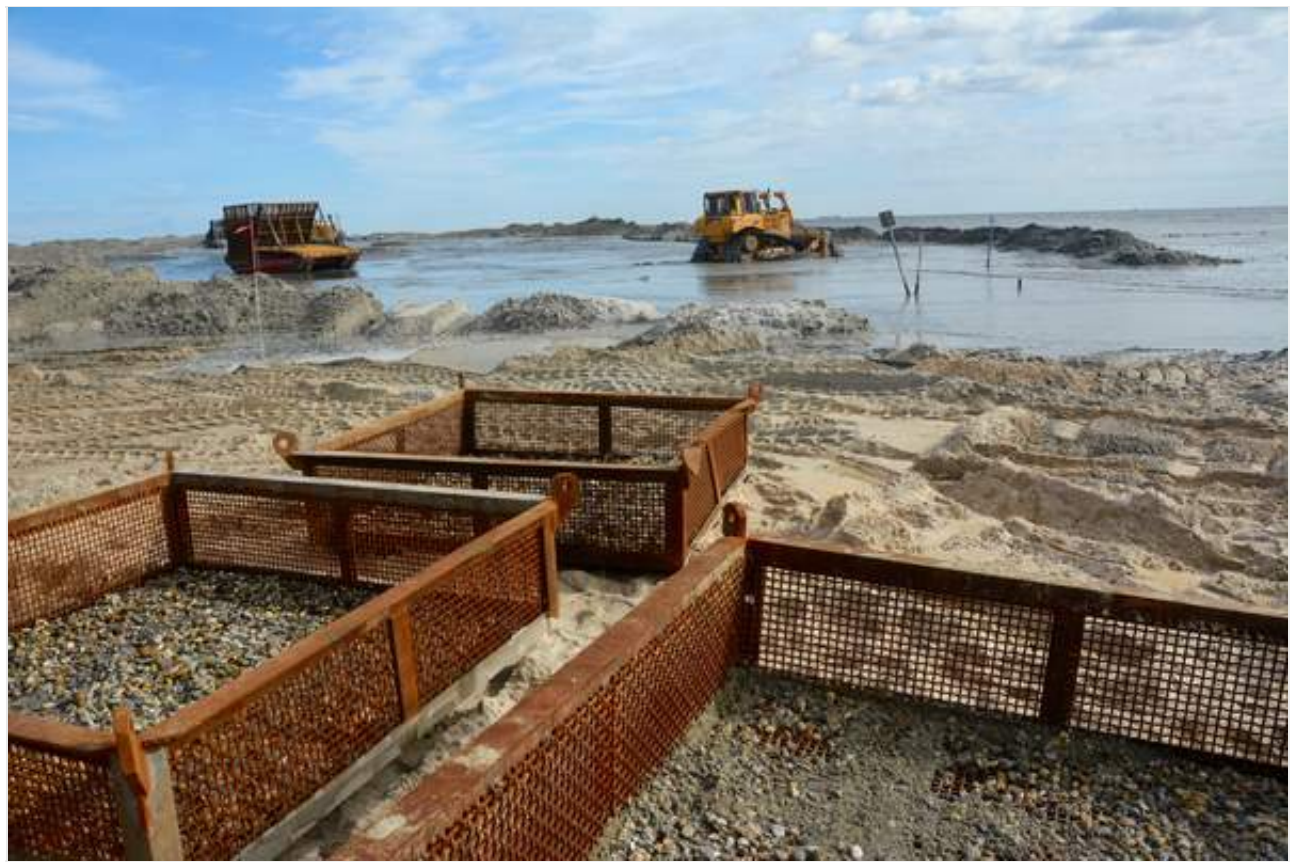
Large stones are filtered out of the sand before it is used on the beach. (*Photo by: Ron MacArthur*)

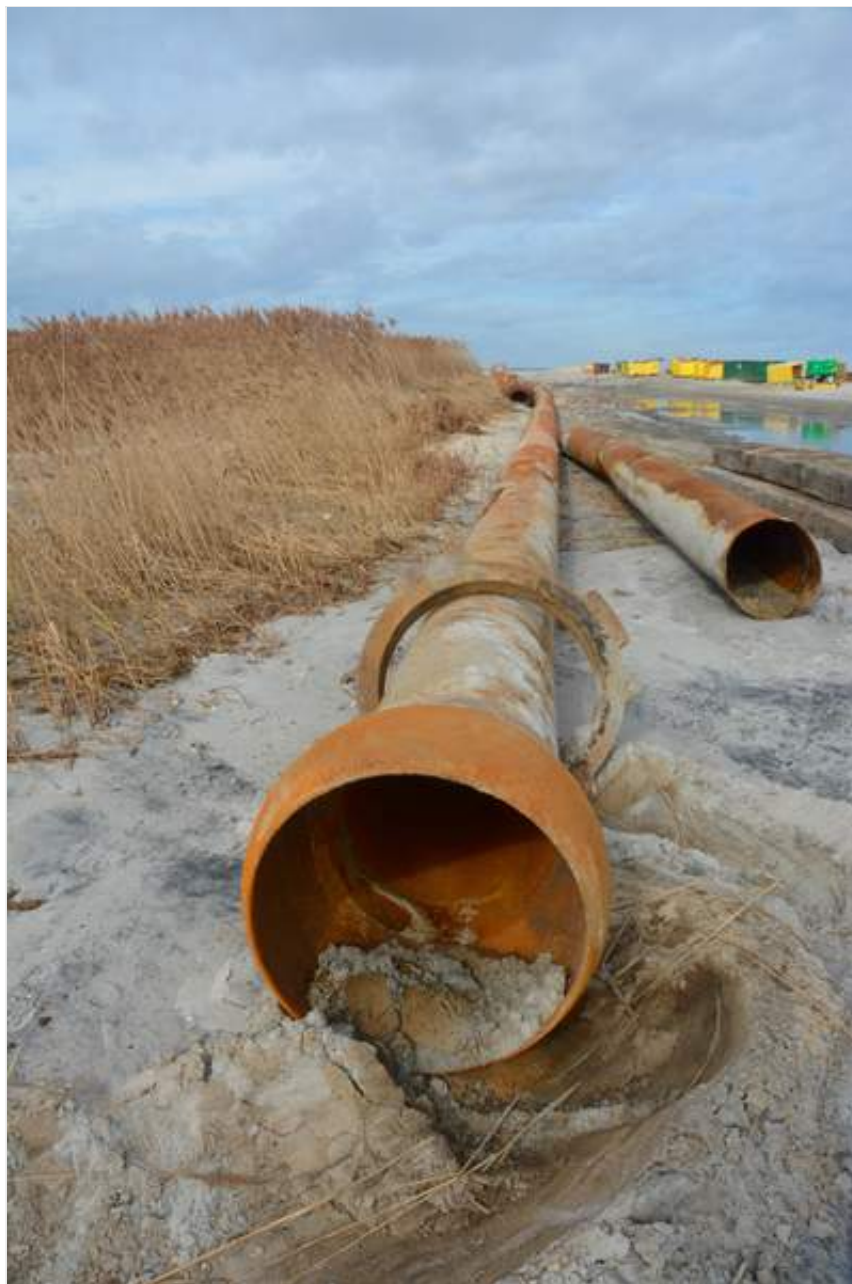
Pipes used for dredging are piled up and ready for use. *(Photo by: Ron MacArthur)*
